OSU BICYCLE PARKING UTILIZATION STUDY 2021

CAPITAL PLANNING AND DEVELOPMENT

APRIL 5, 2022

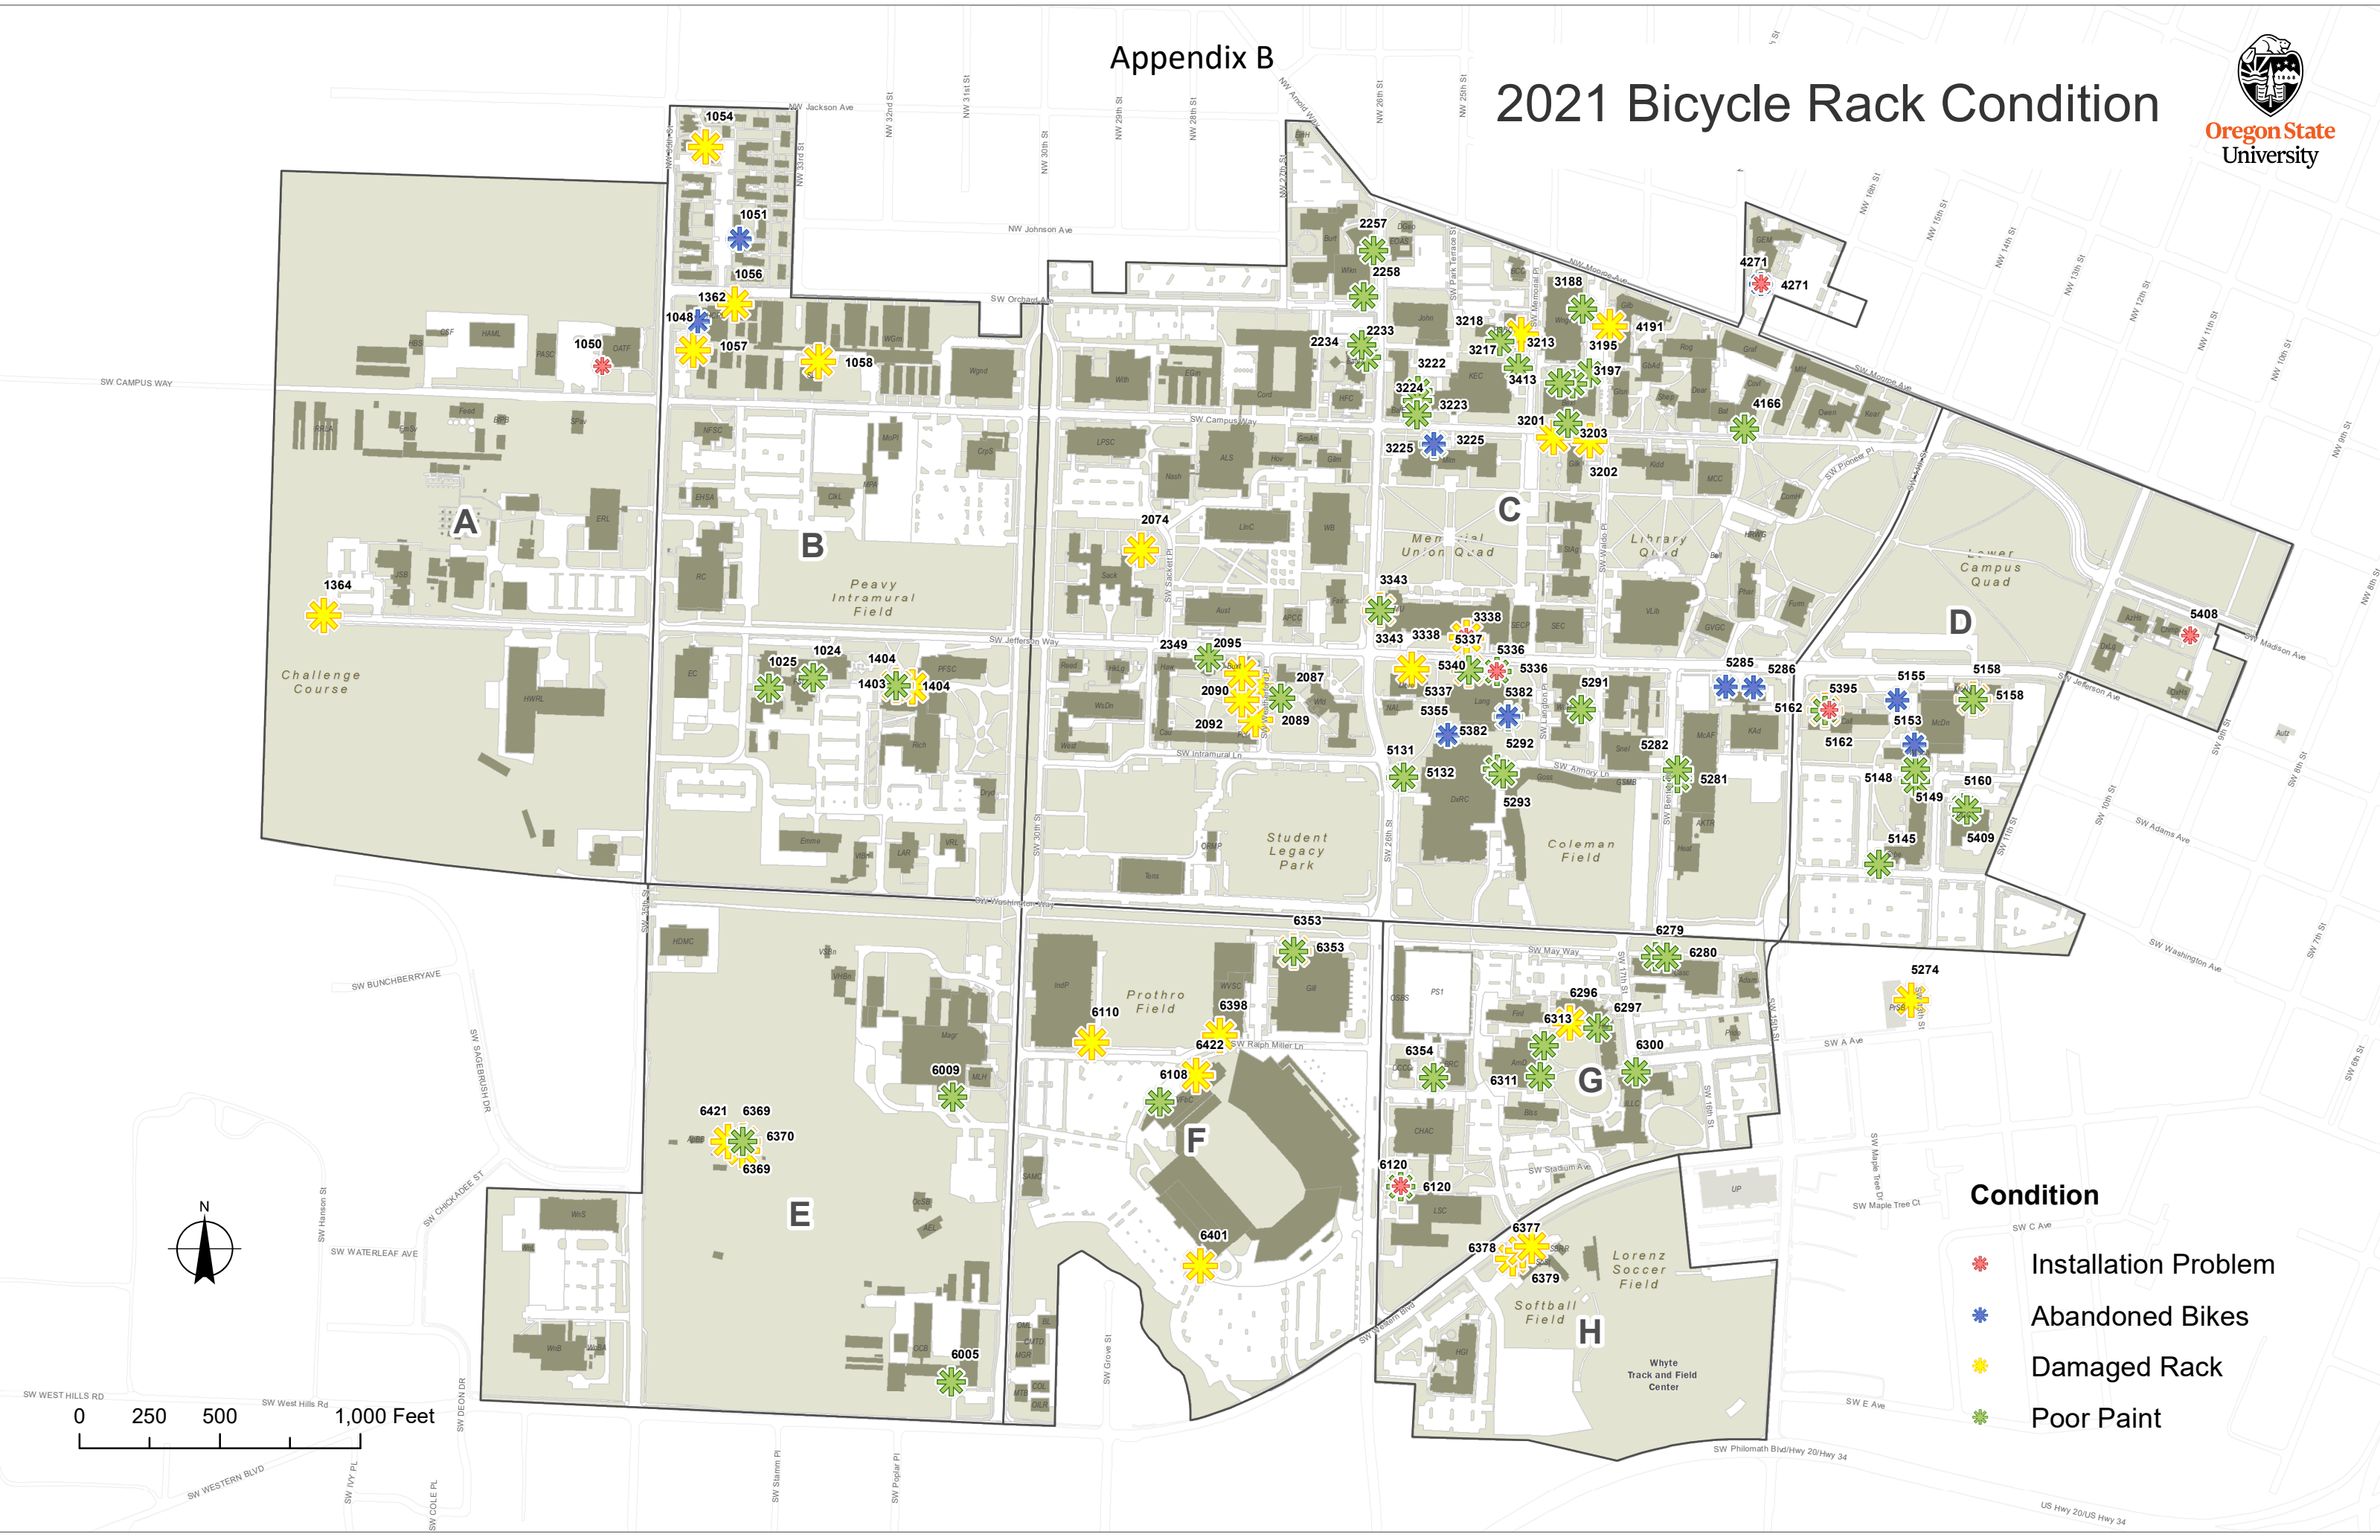
2021 Bicycle Rack Condition

Abandoned Bikes	
Location ID	Abandoned Bikes
1051	y
1362	y
3225	y
4271	y
5153	y
5155	y
5285	y
5286	y
5355	y
5382	y

Damaged / Unanchored Racks	
Location ID	Damaged/Unanchored
1048	y
1054	y
1056	y
1057	y
1058	y
1364	y
1403	y
1404	y
2074	y
2089	y
2090	y
2092	y
2095	y
3202	y
3203	y
3217	y
3338	y
3343	y
4191	y
5158	y
5162	y
5274	y
5337	y
5340	y
6110	y
6296	y
6353	y
6369	y
6370	y
6377	y
6378	y
6379	y
6398	y
6401	y
6421	y
6422	y
6425	y

Rack Installation Problems	
Location ID	Install Problem
1050	y
3338	y
4271	y
5336	y
5395	y
5408	y
6120	y

Bikes out of Racks	
Location ID	Bikes out of Racks
2253	y
3386	y
5154	y

Paint Issues	
Location ID	Paint Condition
1024	poor
1025	poor
1404	poor
2087	poor
2233	poor
2234	poor
2257	poor
2258	poor
2349	poor
3188	poor
3195	poor
3197	poor
3201	poor
3213	poor
3218	poor
3222	poor
3223	poor
3224	poor
3225	poor
3343	poor
3413	poor
4166	poor
5131	poor
5132	poor
5145	poor
5148	poor
5149	poor
5158	poor
5160	poor
5162	poor
5281	poor
5282	poor
5291	poor
5292	poor
5293	poor
5336	poor
5337	poor
5382	poor

Paint Issues (continued)	
Location ID	Paint Condition
5409	poor
6005	poor
6009	poor
6108	poor
6120	poor
6279	poor
6280	poor
6297	poor
6300	poor
6311	poor
6313	poor
6353	poor
6354	poor
6369	poor
